NRL Report 6387

Investigation of the Intergranular Corrosion of Lead-Antimony Grid Alloys

A. C. SIMON

April 7, 1966

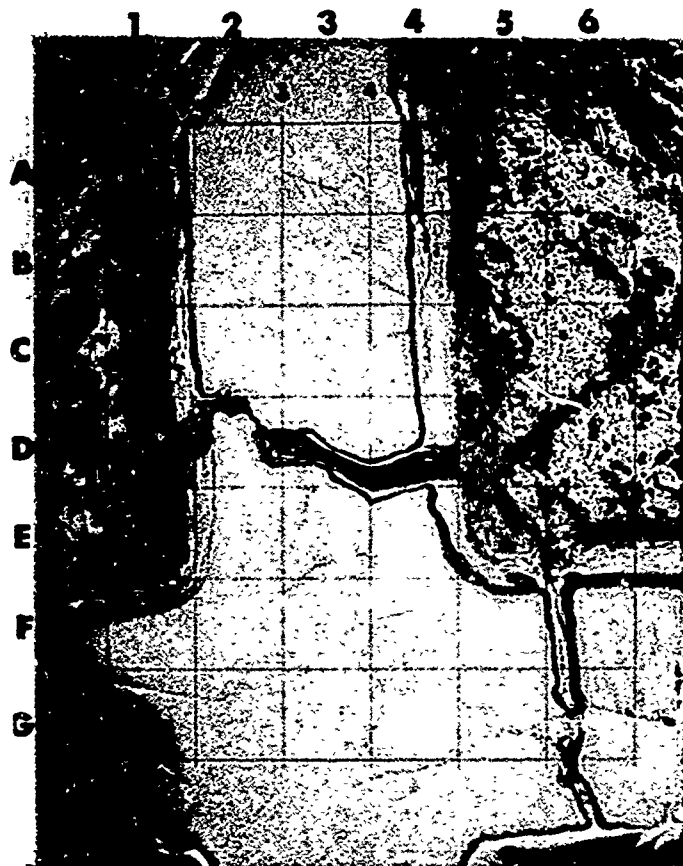
Fig. 1 - A cross section of the junction of two grid members. The photograph shows two major examples of intergranular grid corrosion as found in the 10-year-old battery. A portion of the corrosion layer along the surface of the grid and some of the surrounding active material are also shown. Lines forming the squares are 550 microns apart and the original magnification is 20X.

Figure 1 illustrates several features of this intergranular corrosion that should be mentioned. Although not clearly visible at this magnification, all corrosion resulting in cracking proceeded along grain boundaries, often by rather devious paths. This will be illustrated in later photomicrographs. Although intergranular corrosion cracks could initiate at almost any grain boundary intersecting the surface of the grid, the worst cases were always near the junction of two grid members. At the same time only a small portion of all the grain boundaries that intersected the surface, even at such an intersection of two grid members, showed evidence of such a localized attack.

The crack that crosses the grid at D2, D3, and D4 of Fig. 1 has completely severed the grid, and actual separation has occurred, the space between the two sections being filled with the plastic used in the impregnation. The crack itself extends through the grid, the corrosion product at each side of the grid, and into the active material. There have also been lateral and vertical displacements of the two portions of the grid member. It is concluded that the grid sections were displaced after the plate was removed from the cell and dried, and that this caused cracking of the active material. It seems unlikely that the wet active material would exhibit such a clean fracture. Figure 2 is an enlarged view of D2
